B-29 CLUTCH SPRING RATTLE

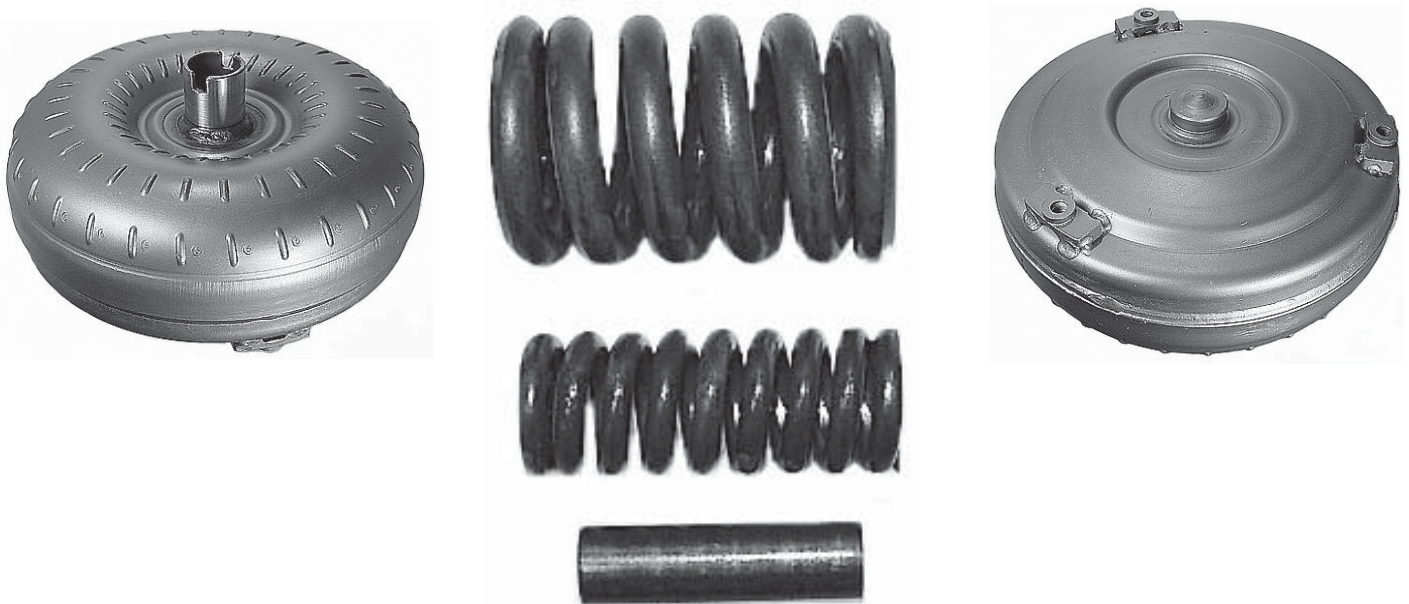
There are some designs in the converter clutch torsional dampening springs that contain a solid "stop pin" inside each of the spring packages.

If the torque converter does not contain fluid or only a small amount of fluid, the "stop pin" may be heard to rattle if the converter is rotated while on its side or installed in the transmission.

This noise is the "stop pin" falling into the spring retainer components that do not allow the springs to be overly compressed and damaged. If the torque converter has been remanufactured and the dampener has been inspected and repaired during the process, the torque converter should be safe to use.

Note: The "stop pin" fits inside the smaller dampening spring and is shorter. The difference in lengths and the movement of these three components that are inside of one another creates the illusion in sound that the torque converter may be damaged internally.
